EVALUATION OF ACCESSIBILITY OF WHEELCHAIR USERS IN THE SMITH BUILDING, ALAM SUTRA, TANGERANG CITY, INDONESIA

The object of study was carried out at The Smith-Alam Sutera building, Tangerang City (Figure 2). The Smith Building is a 33-storey building combining office, SOHO and apartment functions in one building.

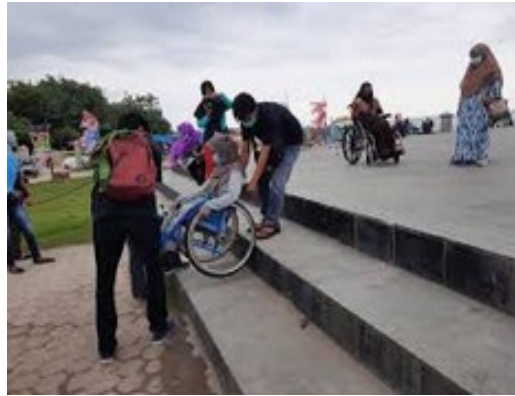
Figure 1. The provision of park facilities has not paid attention to the behavior of people with disabilities

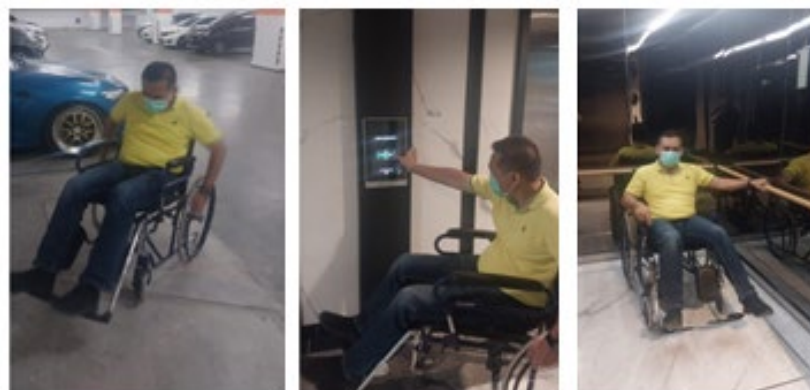
The apartment lobby in the Ground floor area is accessed via the apartment lift lobby in the basement area. Meanwhile, to reach the apartment lift lobby in the basement, wheelchair access will pass through a ramp with a slope of 5% and follow the pedestrian path with a width of 2m to the entrance area of the apartment lift lobby in basement area. The light intensity in the basement area is 116 lux. In the basement area, the movement of wheelchair users has no obstacles in accessing ramps and lifts, lighting conditions, track width and ramp slope do not make it difficult for wheelchair users (Figure 5) but in terms of opening and closing the lobby lift door it cannot be done independently.

Figure 5. Users access by pushing the lift button
Source: personal documentation, 2022

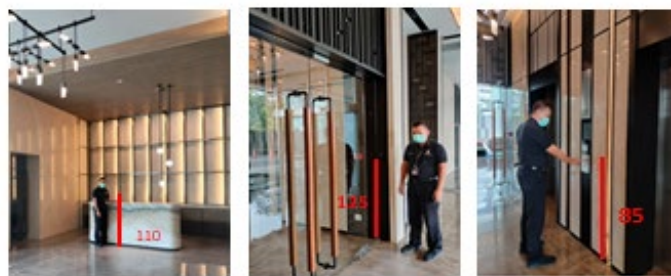
From the apartment lobby on the ground floor leading to the lobby office and garden :
The movement of wheelchair users has no problems accessing the reception area, access sensors, lifts, and push buttons, but in terms of opening and closing the lobby lift doors, it cannot be done independently (Figure 7).

Figure 7. Reception area, push buttons and sensors;

The door to the lobby room uses a hinge system, wheelchair users can still handle the position of the handle, but the position of opening and closing the door cannot be done independently.

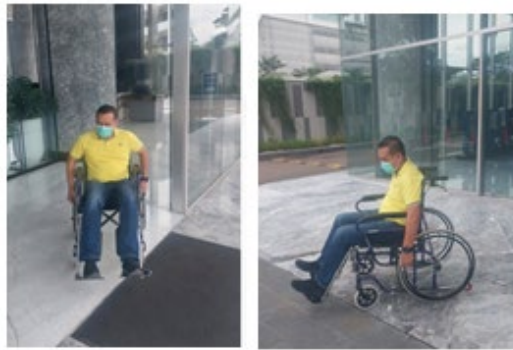
From the apartment lobby in the Ground Floor area, wheelchair users go to the lobby office area before accessing the park, as shown in Figure 8, the movement of wheelchairs in the apartment lobby area to the lobby office has no problems, the movement of wheelchairs is not hampered by the position of the layout of the furniture or lighting conditions. in the room (light intensity in the room 105 lux), at the entrance lobby office. There is a ramp with a 5% slope before entering the drop-off area.

Figure 8. Movement of wheelchair users in the entrance lobby office area;
Source: personal documentation 2022

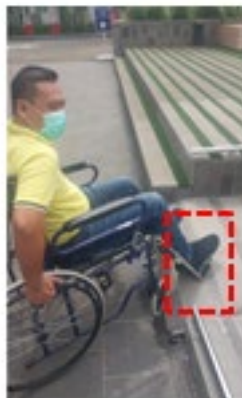
On the south side, the entrance ramp is less sloping, so it becomes a stumbling block to the wheelchair's footrest and hinders movement (Figure 9).

Figure 9. The ramp is less sloping, thus hindering the movement of wheelchairs
Source: personal documentation, 2022

The limited width of the landing at the ending ramp makes it difficult for wheelchair users to maneuver around, especially for novice wheelchair users. The wheelchair movement in the southern ramp area must be assisted so users can access the park. Synthetic grass decorations on the park floor make wheelchairs mired so that it disturbs wheelchair movement when accessing the park.

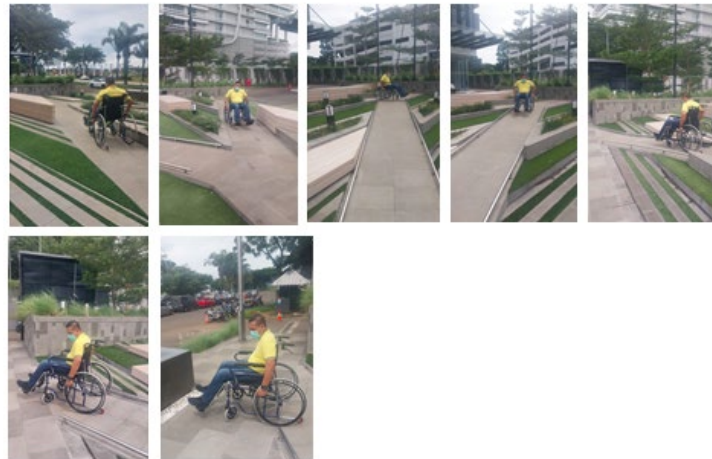
In the area within the park, movement does not experience problems in crossing or rotating the chairs. In the ramp area, the slope of the ramp is relatively flat so it is not equipped with railings that are accessible by hand. Still, handrails are provided on the side so that the movement of chairs stays on the path (Figure 10).

Figure 10. Movement of wheelchairs within the park
Source: personal documentation: 2022

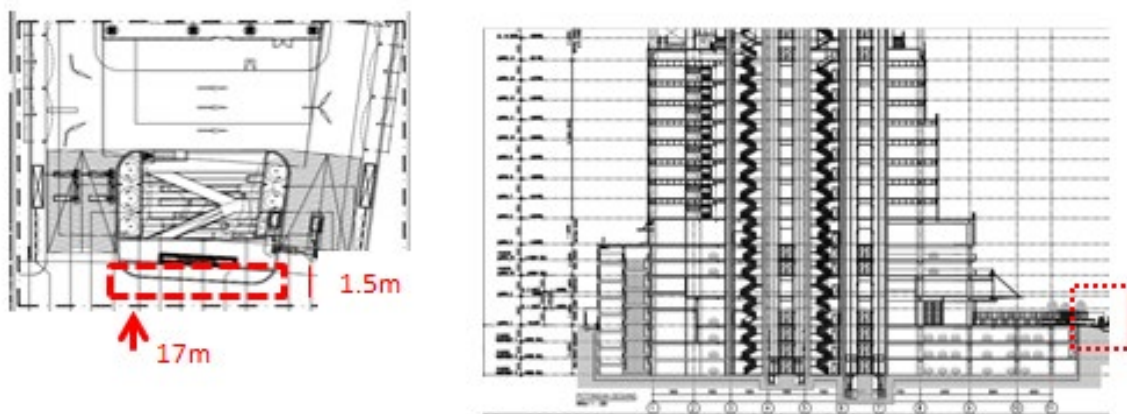
On the park's north side, it is not yet accessible for wheelchair users (only accessible without wheelchairs). The existing condition of the north side, Figure 11 for the proposed area to replace the stairs with ramps is not constrained by the basement construction.

Figure 11. The existing condition of the north side;
Source: building document image, 2022

On the north side of the park, it is not yet accessible for wheelchair users (only accessible without wheelchairs):

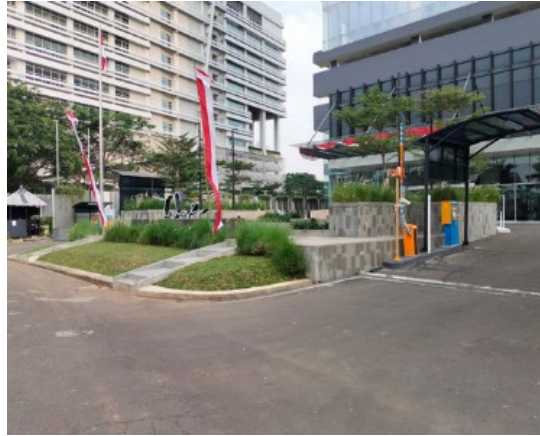
Figure 12. Park situation on the north side
Source: personal documentation, 2022

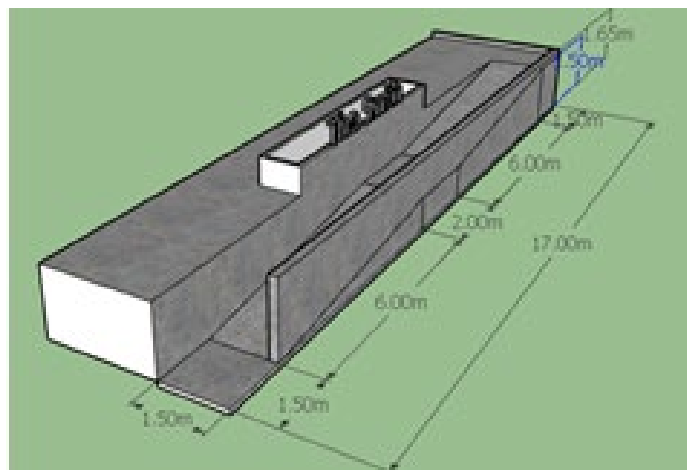
Figure 13. Proposed ramp access concept on the north side
Source: personal sketch image, 2022

1. With the limited width on the north side of the park, only elongated ramps (with landings) with a slope of 1% can only be made.
2. The north side of the entrance ramp is proposed to be on the entrance side (east side), assuming the speed of incoming vehicles is lower than that of exiting vehicles.
3. The ramp material uses andesite stone with a stone arrangement pattern that matches the existing conditions. The use of andesite stone in new buildings gives the impression of oneness between the new building and the existing conditions.
4. Parapets are provided on the north side of the ramp to prevent wheelchairs from slipping off the track.

1. Limited width on the north side of the park, so only elongated ram paths (with landings) with a slope of 1% can be made
2. The north side of the entrance ramp is proposed to be on the entrance side (east side) assuming the speed of incoming vehicles is lower than that of exiting vehicles

3. The ramp material uses andesite stone with a stone arrangement pattern that matches the existing conditions. The use of andesite stone in new buildings gives the impression of oneness between the new building and the current conditions.
4. Parapets are provided on the north side of the ramp to prevent wheelchairs from slipping off the track.

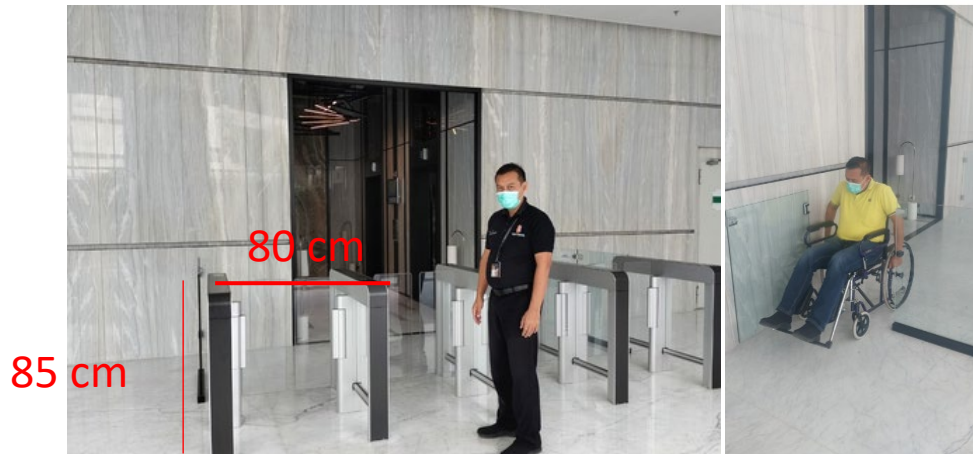
The movement of office and SOHO area users from the side of the parking section to the lobby office area in the Ground Floor area is the same as the apartment area, but on the entrance lobby side of the Ground Floor, the movement of wheelchairs must go through a special door (Figure 14)

Figure 14. A special door for wheelchair users at the entrance to the lobby office
Source: personal documentation, 2022
