EVALUATION OF ACCESSIBILITY OF WHEELCHAIR USERS IN THE SMITH BUILDING, ALAM SUTRA, TANGERANG CITY, INDONESIA

The object of study was carried out at The Smith-Alam Sutera building, Tangerang City (Figure 2). The Smith Building is a 33-storey building combining office, SOHO and apartment functions in one building.

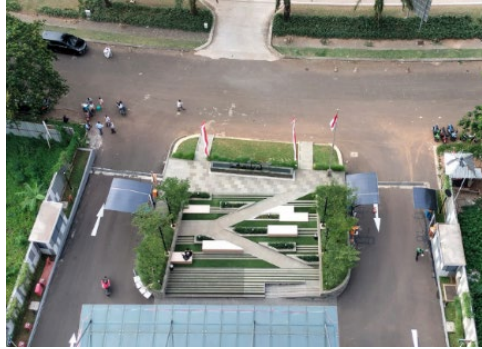
Figure 3. Observation area 2;
Source: Personal documentation and marketing brochure, 2020

area, which functions as an area of social interaction for residents. The garden area can be accessed from the north side of the building (outer side), the basement area (parking area), and from the tenant area (office, SOHO, and apartments). This new building was firstly operational in the 2019, and until this study was carried out, wheelchair users did not yet exist. Therefore, the activity of surveying the accessibility of wheelchair users to the building's garden was carried out through an experiment.

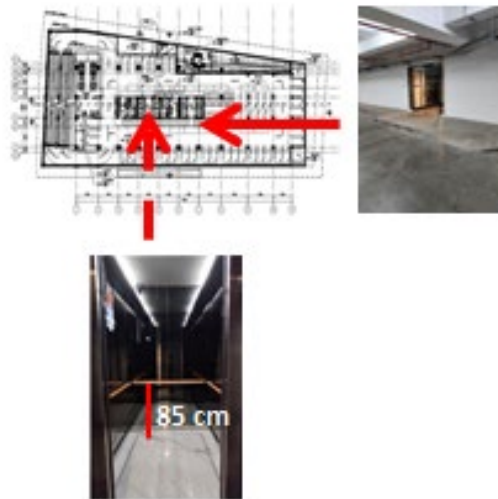
Figure 4. Movement from the parking area to the park
Source: personal documentation 2022

The route of occupant movement from the parking area to the park is shown in Figure 4 below.

Parking Area → Apartment Lobby → Office Lobby → Drop-off Area → Park

The apartment lobby in the Ground floor area is accessed via the apartment lift lobby in the basement area. Meanwhile, to reach the apartment lift lobby in the basement, wheelchair access will pass through a ramp with a slope of 5% and follow the pedestrian path with a width of 2m to the entrance area of the apartment lift lobby in basement area. The light intensity in the basement area is 116 lux. In the basement area, the movement of wheelchair users has no obstacles in accessing ramps and lifts, lighting conditions, track width and ramp slope do not make it difficult for wheelchair users (Figure 5) but in terms of opening and closing the lobby lift door it cannot be done independently.

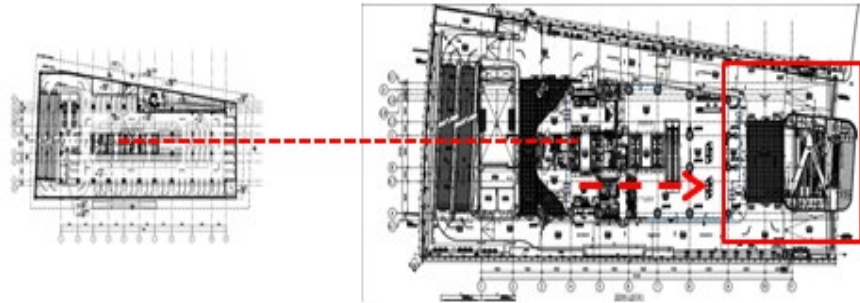
Figure 6. Movement from the basement lobby, GF apartment lobby, office lobby, and towards the park;

From the parking area, the movement of wheelchair users to the park will pass through the lobby lift in the Ground floor area and then to the lobby office and drop-off area before accessing the park (Figure 6).
